SOILS
ROTORUA 2024

Joint NZSSS and SSA Conference “Te Kiri o Papatūānuku”
2nd to 5th December 2024, Rotorua Energy Events Centre, NZ

PASTORAL CARE OF ROTORUA FIELD TRIP HANDBOOK

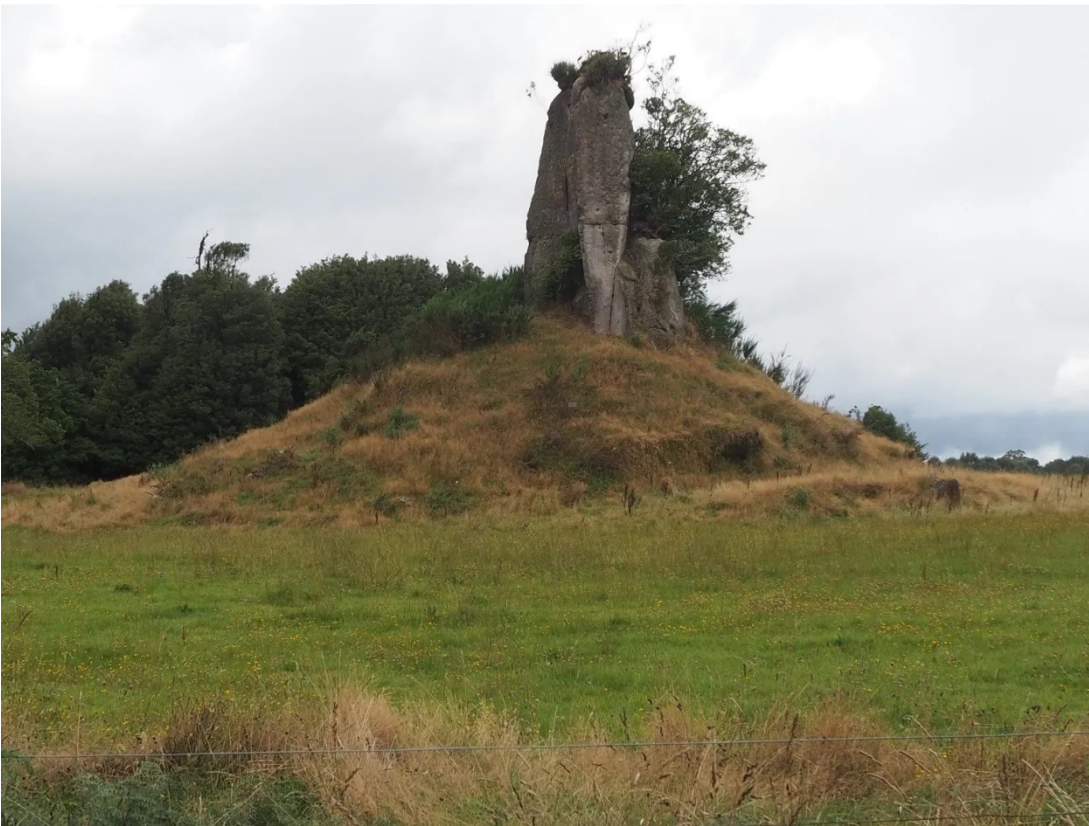
Figure 3: Mamaku Ignimbrite, erosion remnant rock columns

The Rotorua caldera formed 220,000 years ago as a result of vast rhyolitic eruptions that produced the Mamaku Ignimbrite, which outcrops on the Mamaku Plateau (Figure 3). The Mamaku ignimbrite comprises over 200 cubic km of material (enough to bury greater Auckland with a 2 km thick layer of ignimbrite) that erupted as a series of pyroclastic flows, burying the pre-existing landscape to the north and west of Rotorua (Houghton and Scott 2008). It is hard to imagine the size of such an eruption. In this case the explosion flung more than 200 cubic kilometres of molten rock perhaps 25 kms into the air. The molten rock then fell back to earth, blasting out across the landscape like a fiery avalanche (the pyroclastic flow). It destroyed everything in its path, burying the landscape under a layer of ignimbrite (gaseous rhyolitic lava that contains pumice, clasts of the rock through which it erupted, and materials from the preexisting land surface that are caught up in the eruption). When the ignimbrite came to rest, in some places it was hot enough and thick enough (up to 200 m thick in some places) to weld into a hard rock. In other places it was not so strongly welded and so more easily eroded. The Mamaku ignimbrite covered perhaps 400 km² to the north, west and south-west of Rotorua and formed the gradually sloping Mamaku Plateau, which State Highway 5 runs through connecting Rotorua with Tirau and Cambridge. Erosion during the last 200,000 years (and particularly during the last glaciation) has gradually cut into the ignimbrite, wearing away the softer parts and leaving a series of harder rocky hillsides and bare rock columns. The ignimbrite erosion remnants are particularly noticeable on State Highway 5 between Tarukenga and Galaxy Roads. The nearly uniform height of the outcrops indicates the thickness of the layer of ignimbrite that smothered the land there so long ago. We will see them at Holdems' farm.

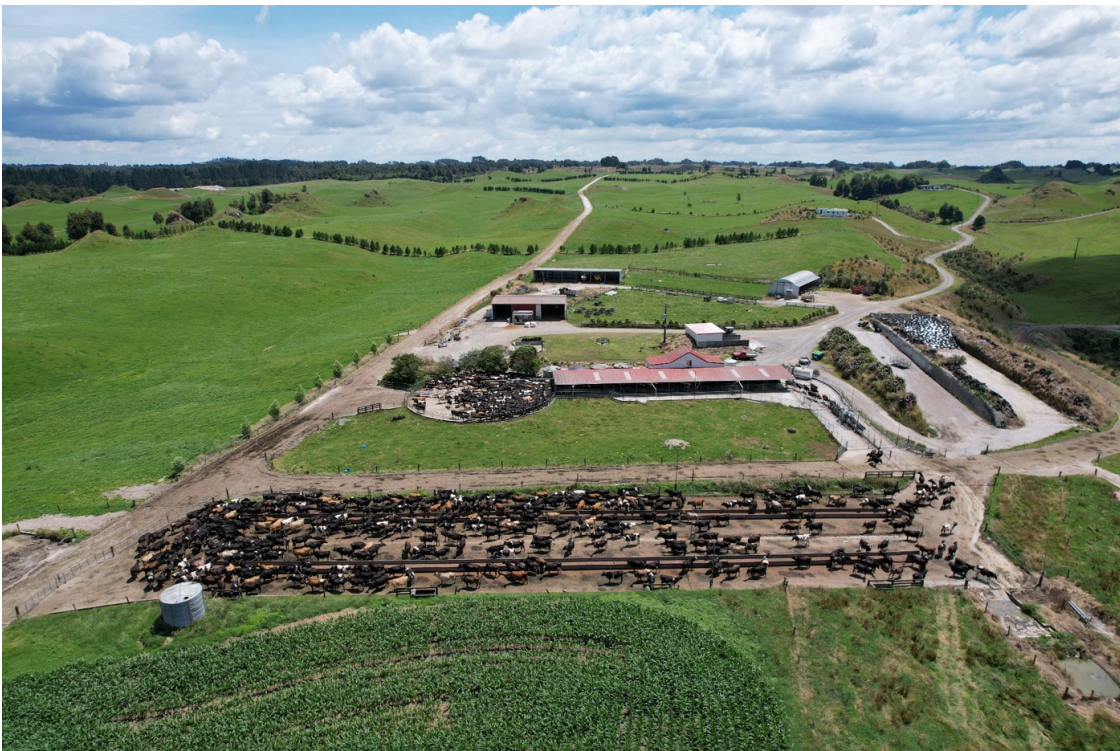
Figure 5: Aerial shot of cowshed and feedpad.

Dairy infrastructure: 55-a-side Herringbone shed, cup removers, Protrack drafting. 600 cow feedpad. 2 large silage bunkers (1 concrete lined). Covered PKE and fertiliser bunkers. 3 implement/calf sheds. 3 rhyolite quarries used as stand-off pads during winter wet periods (Figure 5).

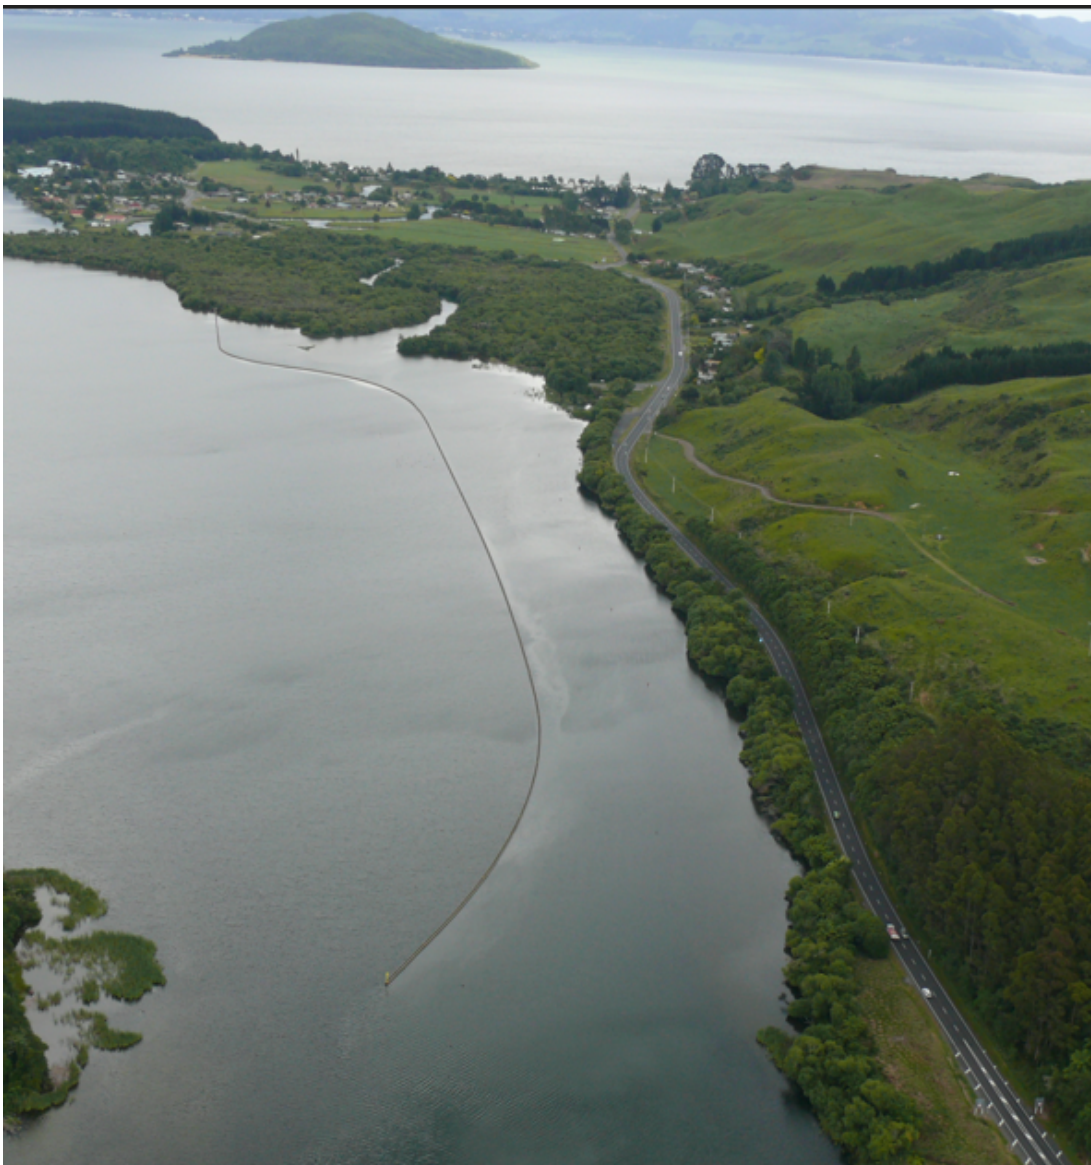
Figure 10: Aerial image of Ohau diversion wall

The Ohau Diversion wall is a 1300m steel sheet pile wall (Figure 10). Constructed in 2007/08. Formed by driving king piles into the bedrock and filling the gap between each king pile with 2 sheet piles. The king piles go down up to 70 m while the sheet piles are only driven down into the sediment at 6 to 8 m.

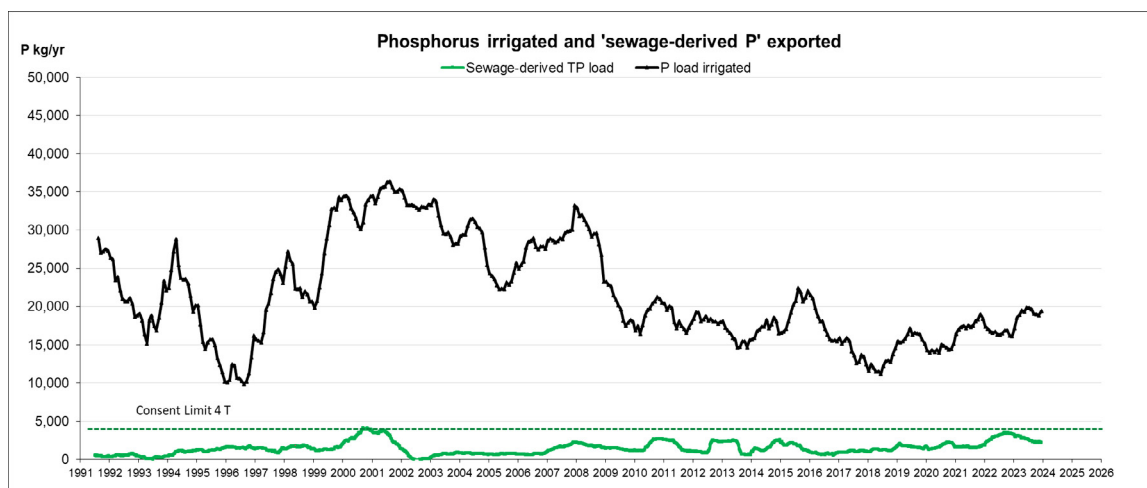
- The LTS continues to retain the applied P
- Together the treatment plant and land treatment system remove 37 t P from Rotorua's wastewater each year
- The residual 3 t P enters Lake Rotorua

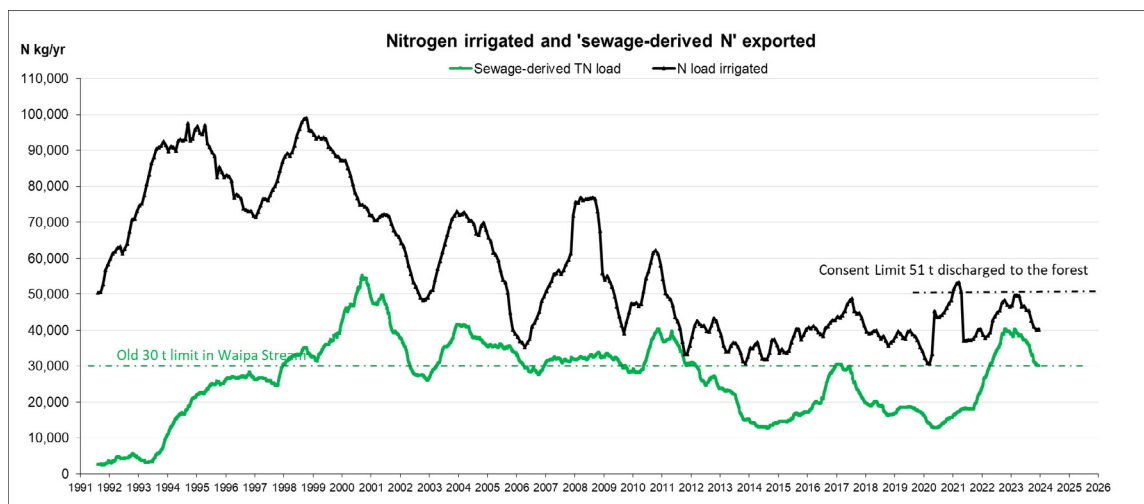
- Together the treatment plant and land treatment system remove 330 t N from Rotorua's wastewater each year
- Residual 30 t N enters Lake Rotorua
- Nitrogen leaching is highly related to rainfall and nitrate concentration
